## **Assessment of Dam Safety of Coal Combustion Surface Impoundments**

**Indianapolis Power & Light Company**

**Harding Street Generating Station**

**June 4, 2010**

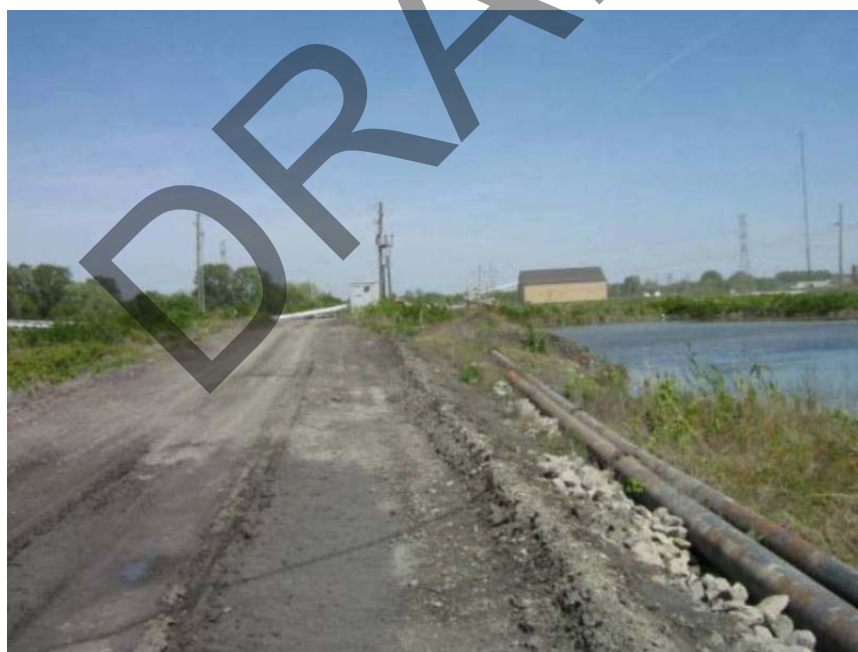
51. Ash Pond 2A - North Embankment Crest, Looking East

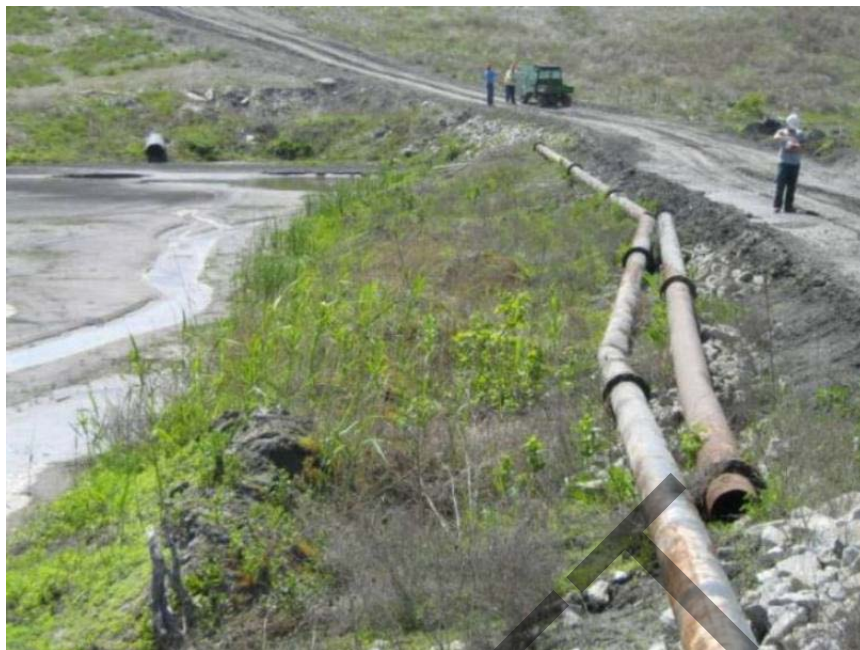
52. Ash Pond 2A - North Embankment Interior Slope, Looking West

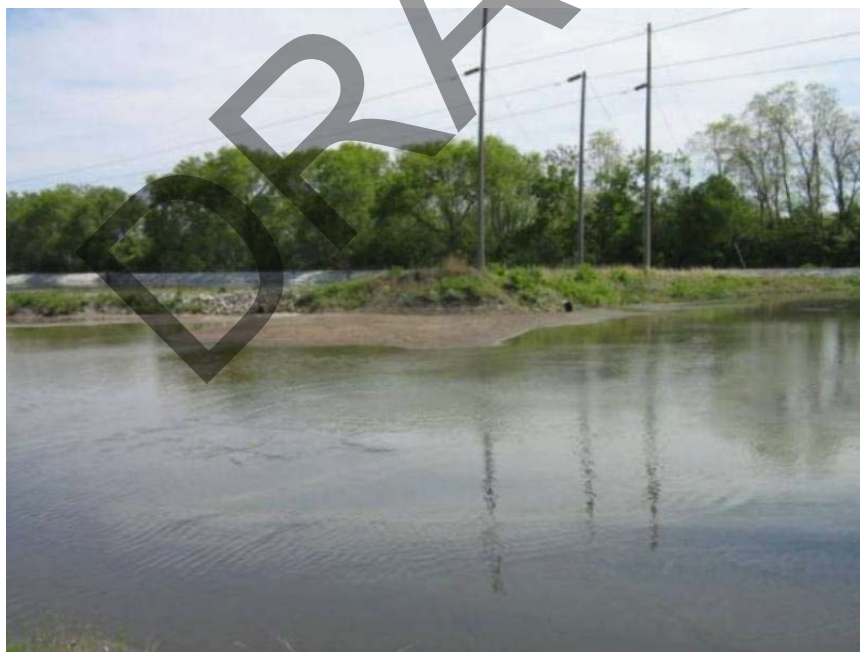
53. Ash Pond 2A - South Embankment Interior Slope, Looking South

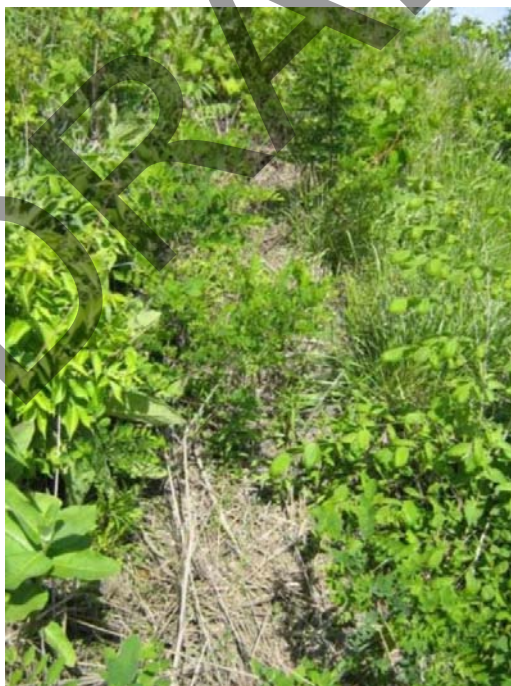
55. Ash Pond 2A - Vegetation and Erosion on North Embankment

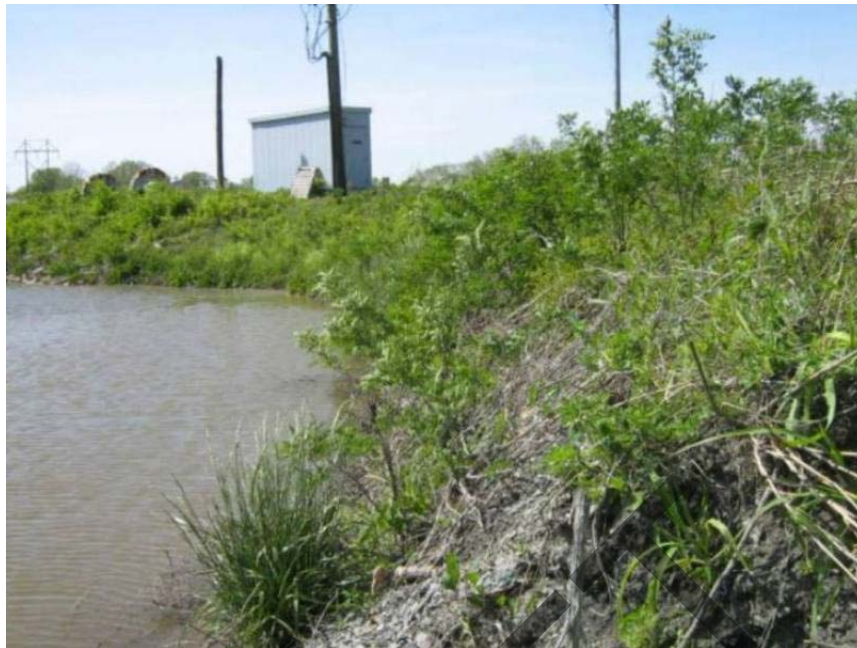
56. Ash Pond 2A - East Embankment Interior Slope, Looking North,  
Approximate 1H:1V Slope

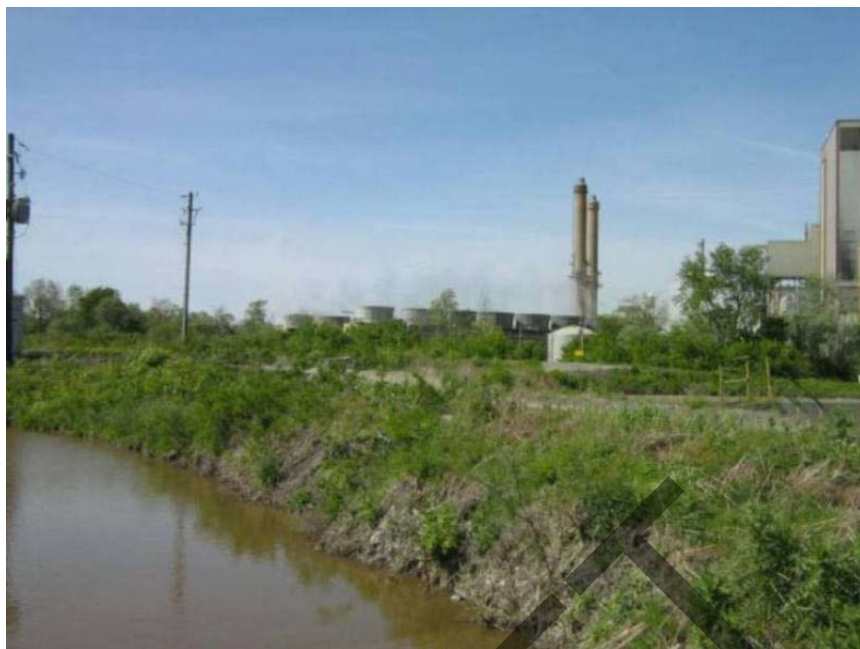
58. Ash Pond 2A - Overview of Steep East Embankment Interior Slope, Looking North, Approximate 1H:1V Slope

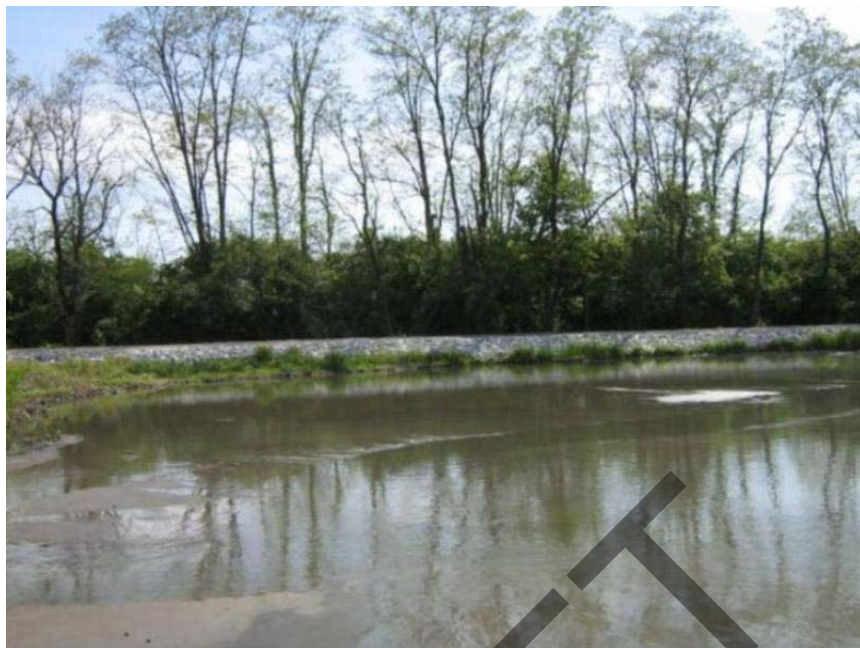
60. Ash Pond 2A - South Embankment Interior Slope, Looking South

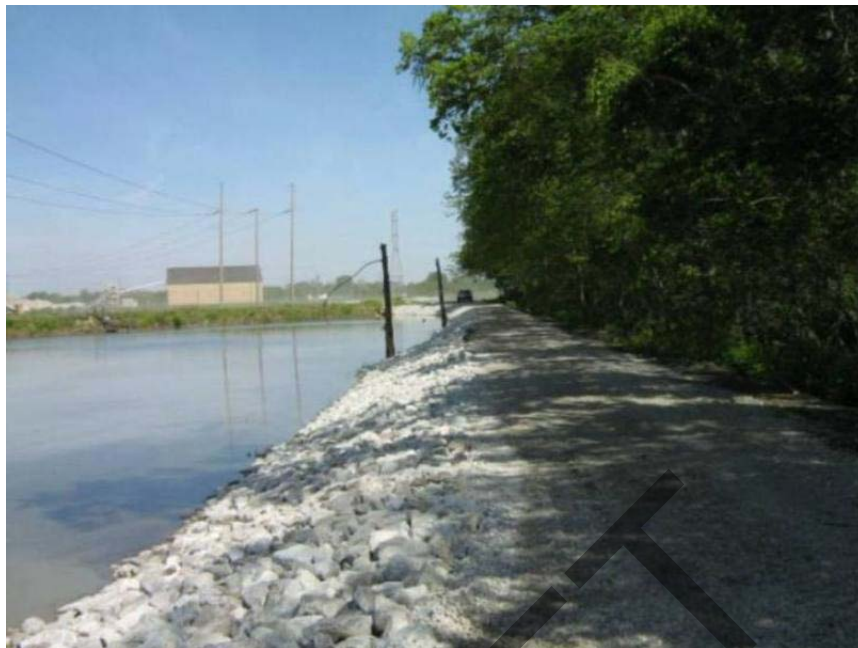
62. Ash Pond 2B - South Embankment Crest and Interior Slope, Looking East

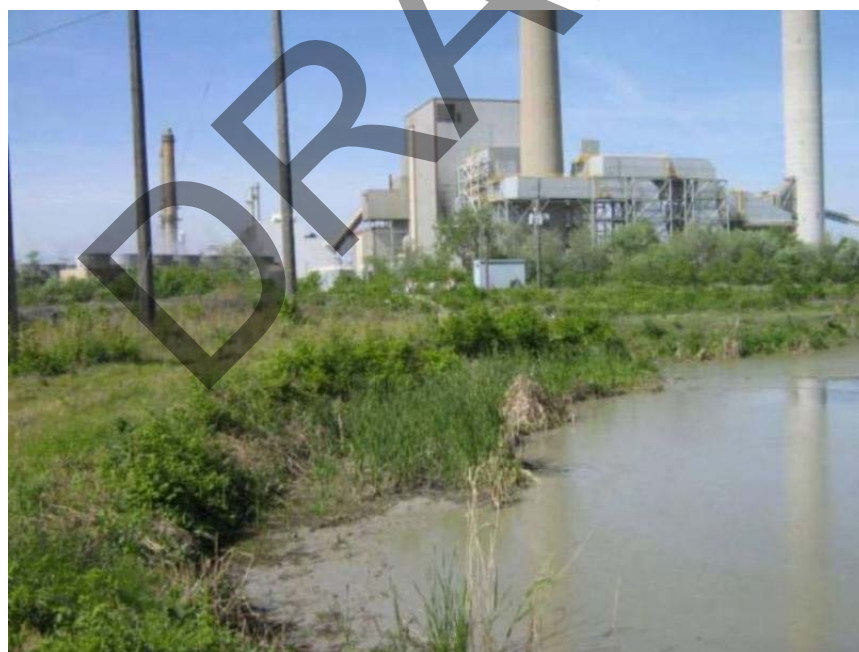
63. Ash Pond 2B - West Embankment Interior Slope, Looking North

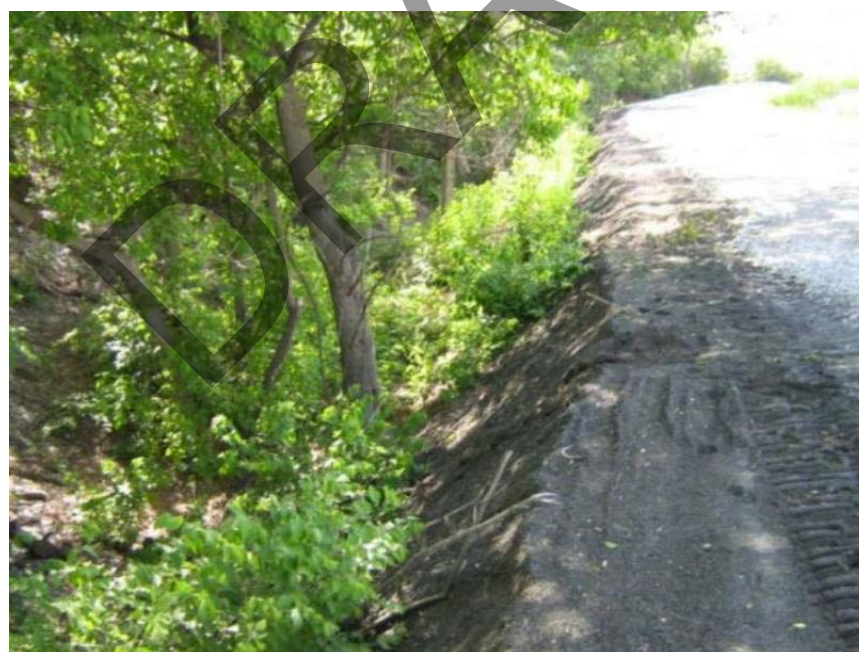
65. Ash Pond 2B - Vegetation along South Embankment Exterior Slope

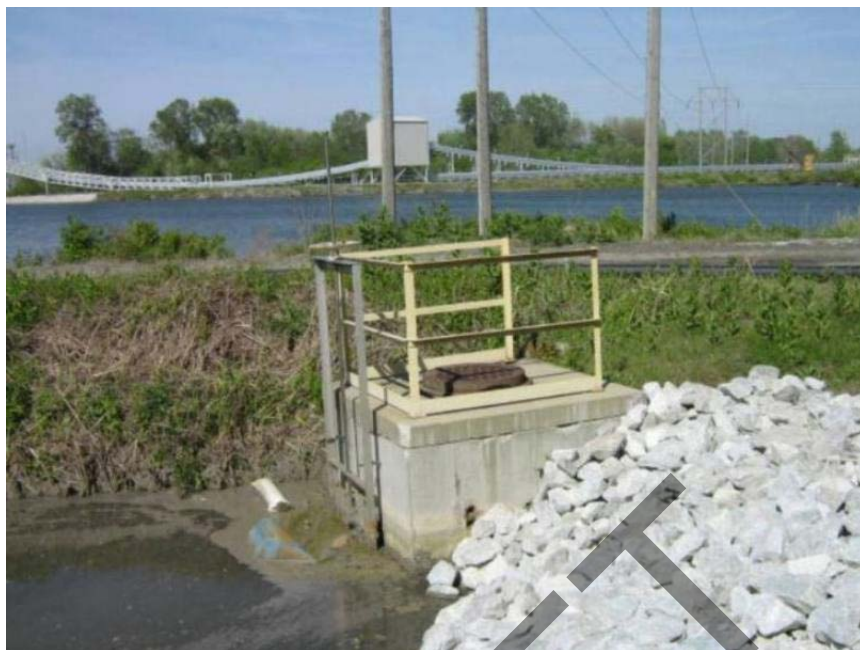
66. Ash Pond 2B - Outlet Structure at East End of South Embankment

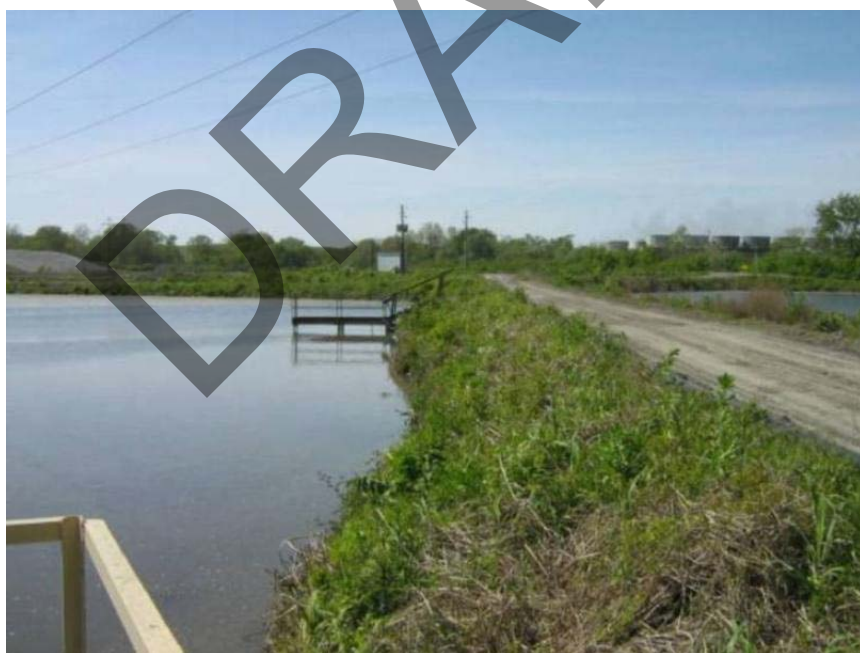
67. Ash Pond 2B - East Embankment Interior Slope, Looking North, Vegetation and Steep Slopes

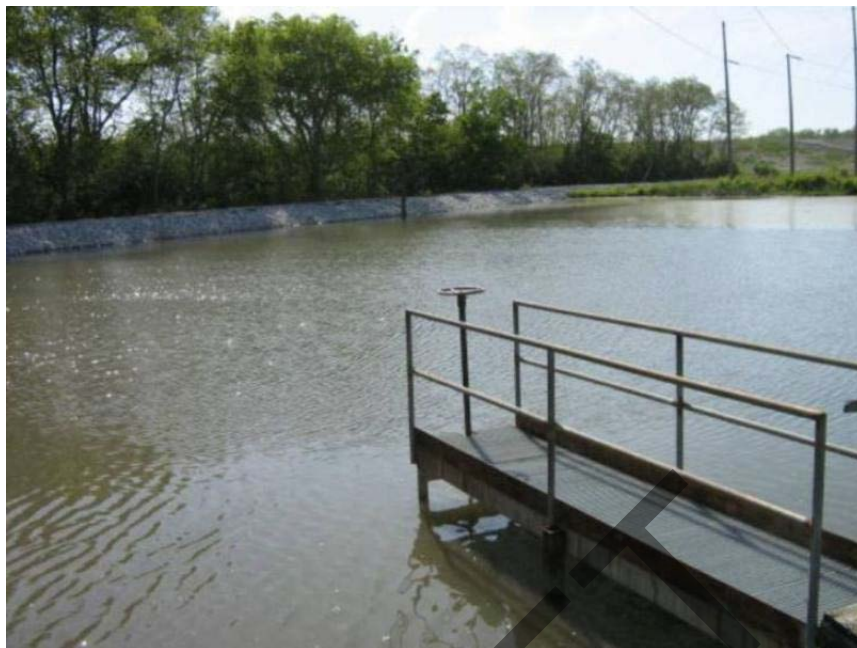
68. Ash Pond 2B - Valved Outlet Access from East Embankment

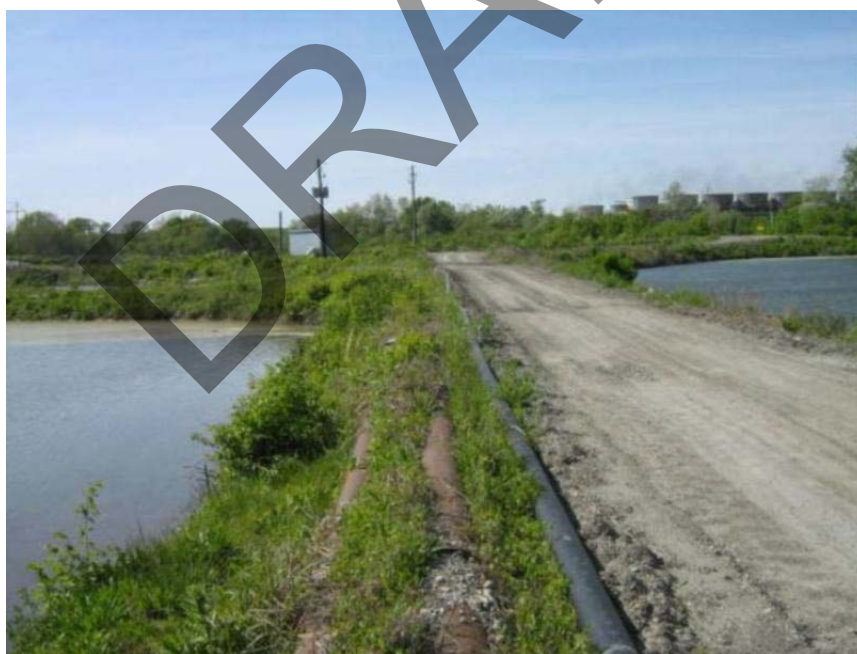
69. Ash Pond 2B - Sluice Lines (Hydroclone and Sump) along Crest and Interior Slope of East Embankment, Looking North

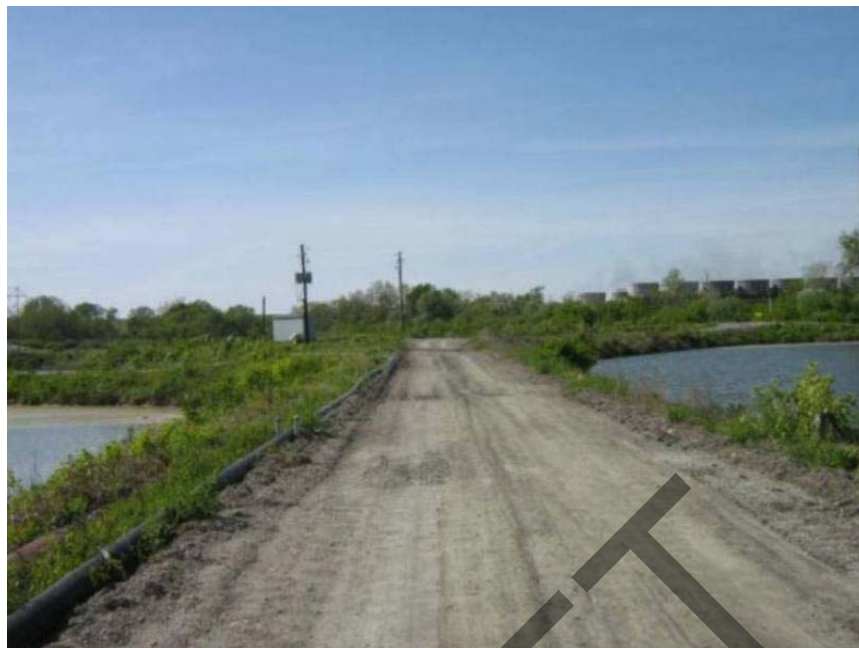
70. Ash Pond 2B - East Embankment Crest, Looking North

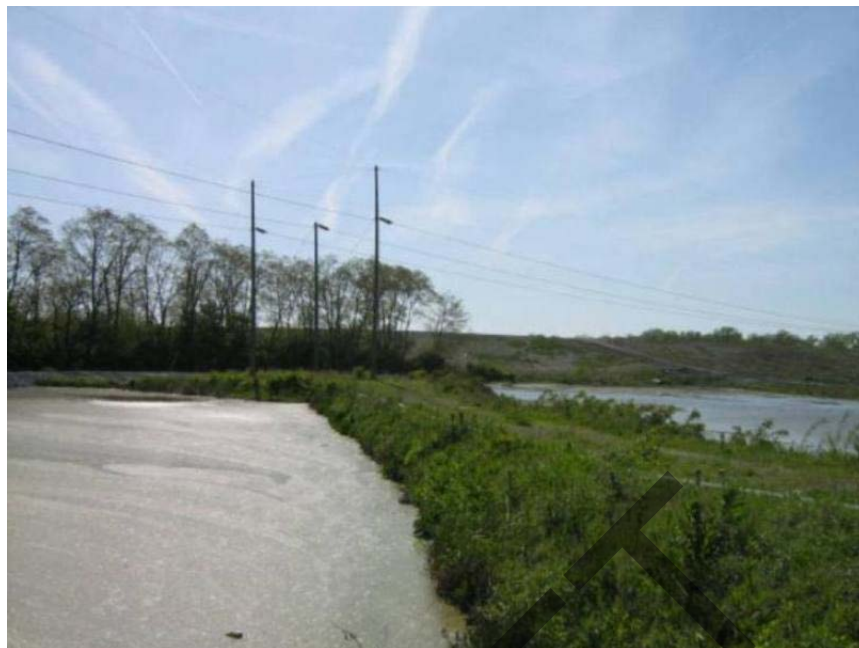
72. Ash Pond 2B - North Embankment Interior Slope, Looking West

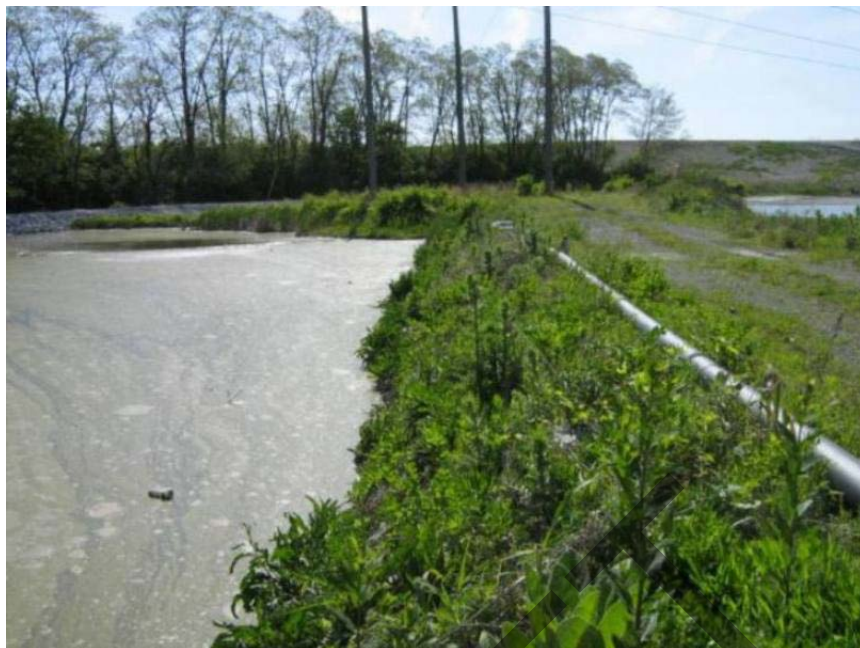
74. Ash Pond 2B - North Embankment Interior Slope, Looking West

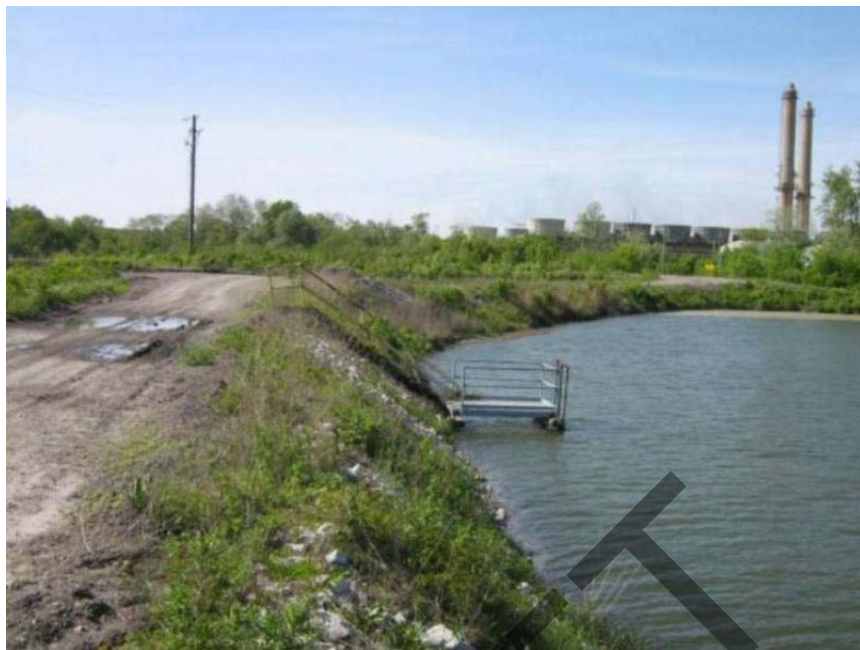
75. Ash Pond 3 - Inlet (3 Valves) Along West Embankment Interior Slope, Looking North

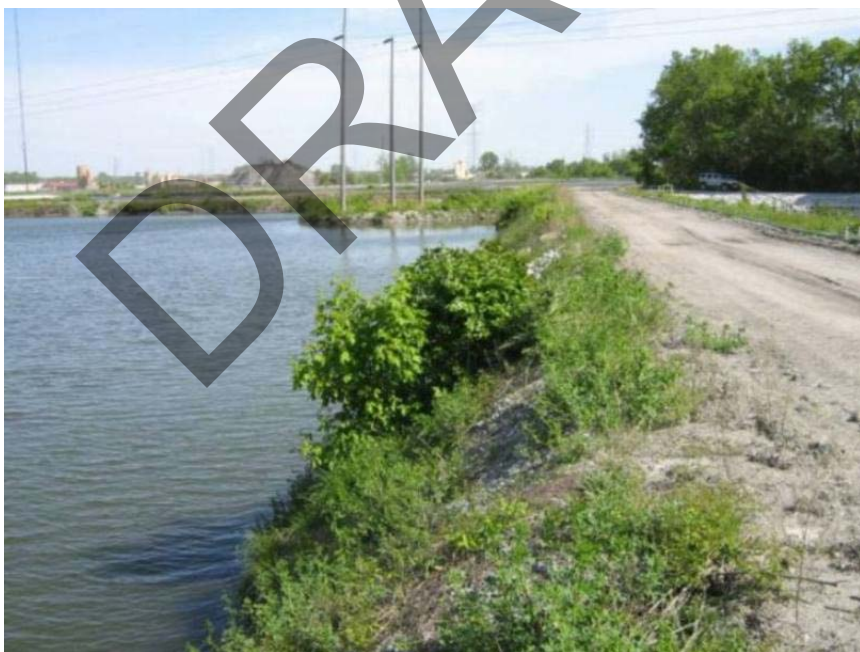
76. Ash Pond 3 - West Embankment Interior Slope, Looking South

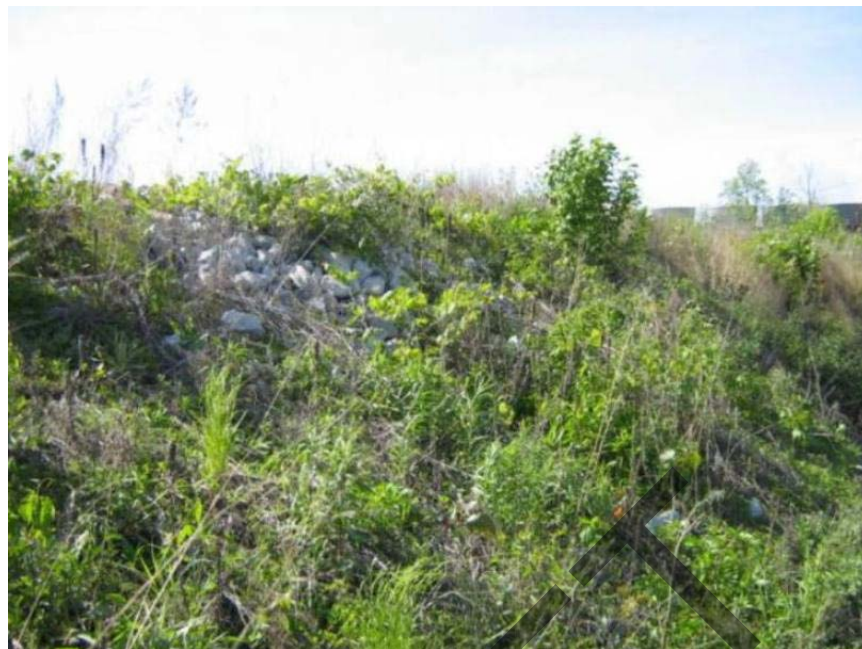
79. Ash Pond 3 - Riprap used to Stabilize Slope along West Embankment Interior Slope

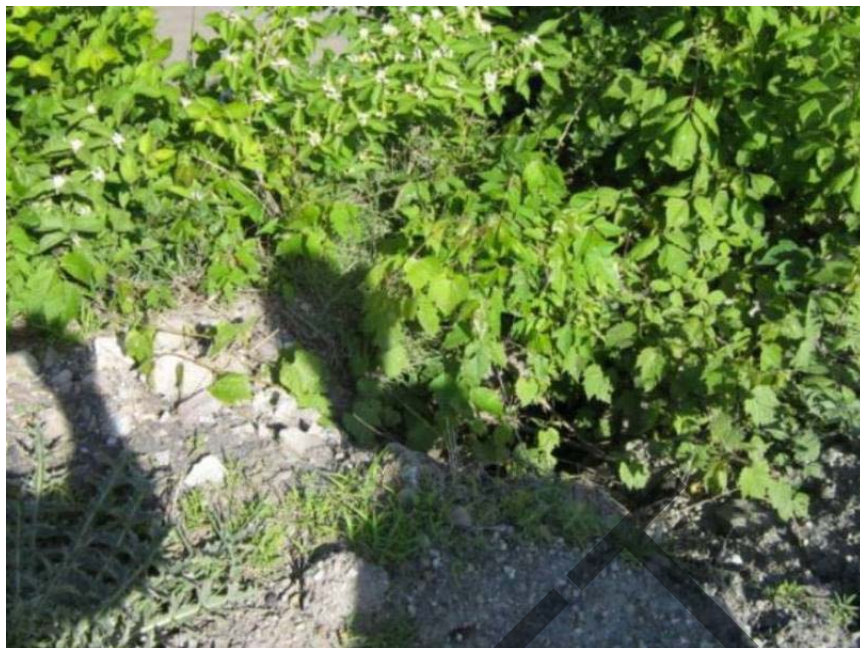
81. Ash Pond 3 - Surface Erosion at top of West Embankment Interior Slope

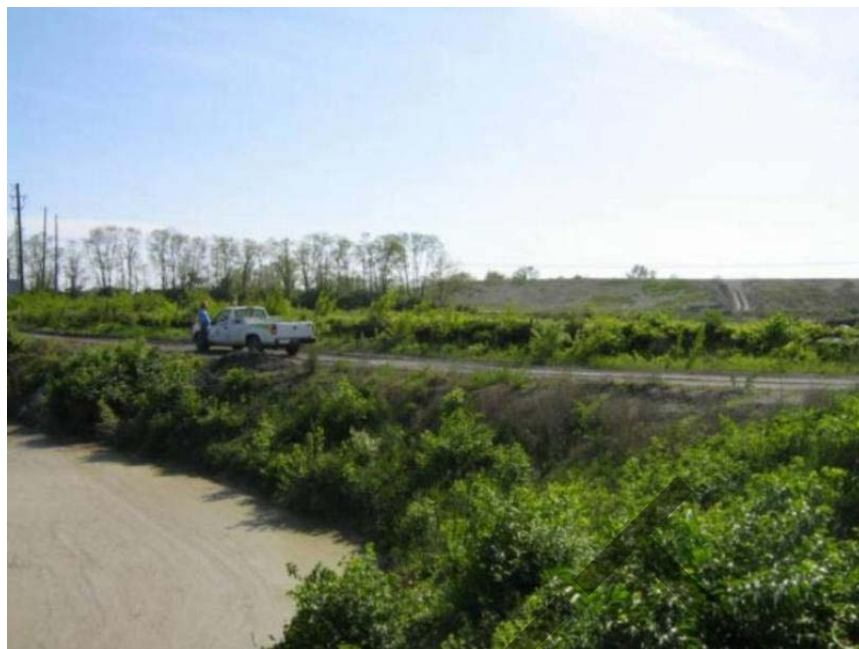
83. Ash Pond 3 - Vegetation on West Embankment Interior Slope,  
Looking West

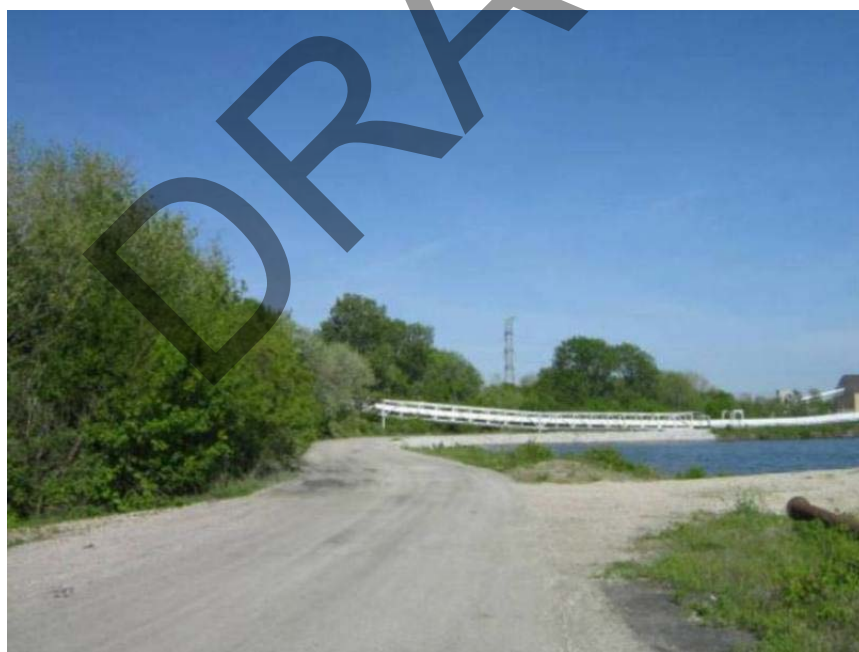
84. Ash Pond 3 - North Embankment Crest, Looking East

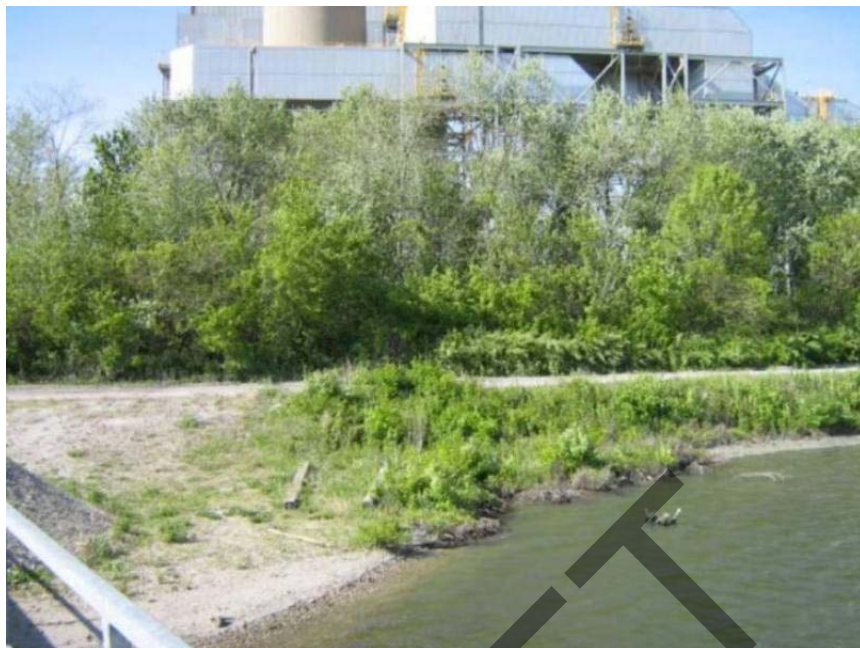
85. Ash Pond 3 - North Embankment Interior Slope, Looking North  
From Outlet Control Structure

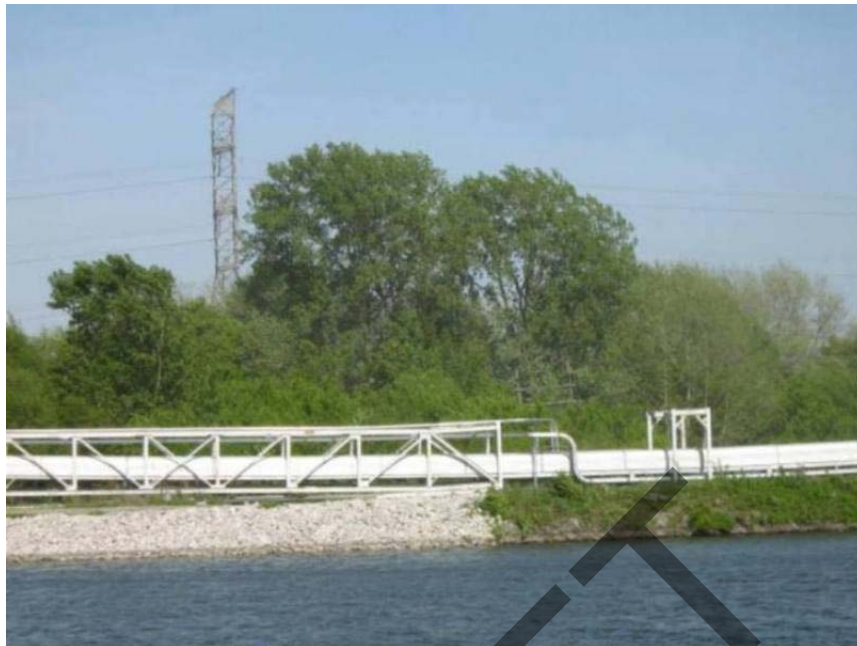
87. Ash Pond 3 - East Embankment Interior Slope, View from Outlet Control Structure

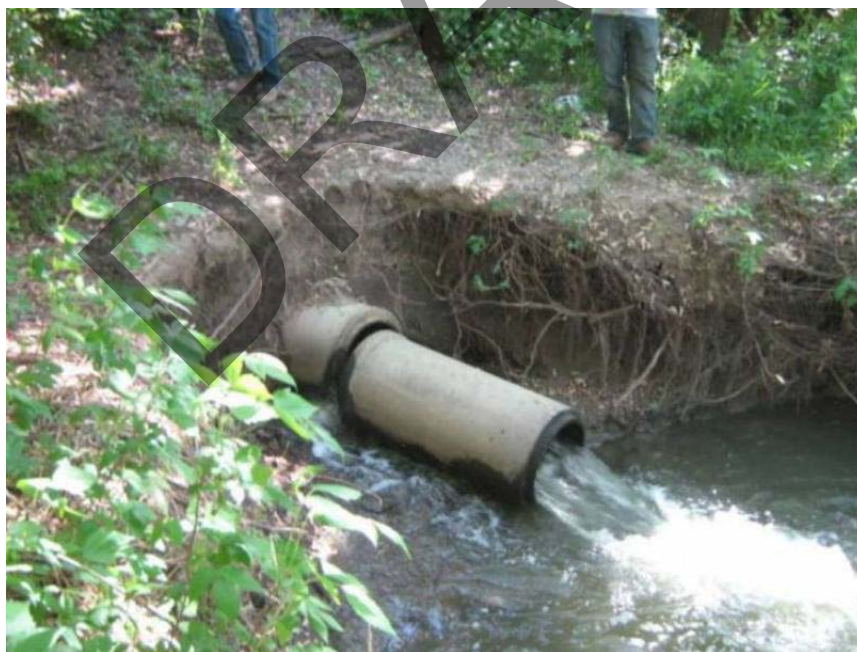
88. Ash Pond 3 - Discharge into Lick Creek, North of Ash Pond 3

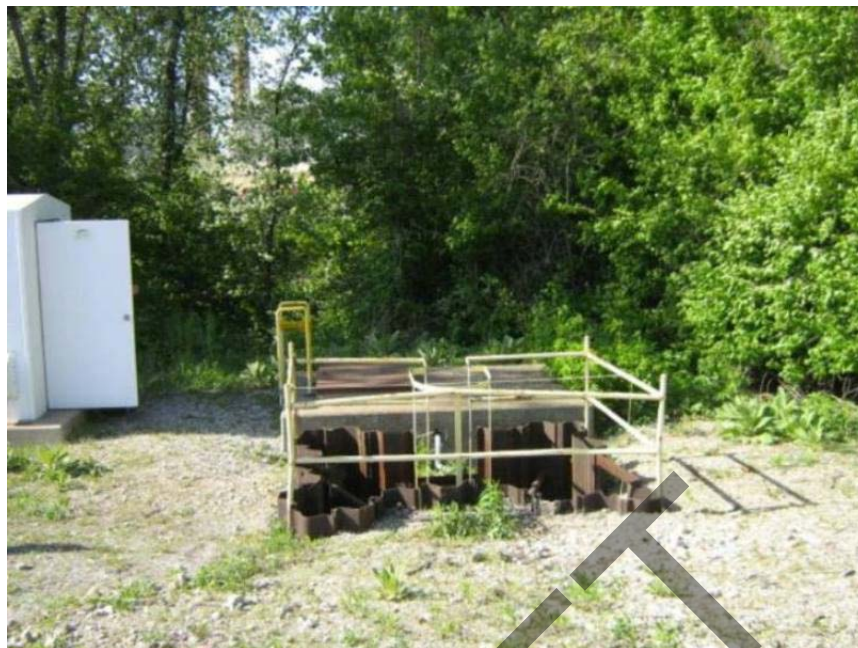
89. Ash Pond 3 - Ash Pond 3 Drop Inlet Structure/Discharge to Lick Creek, Looking North

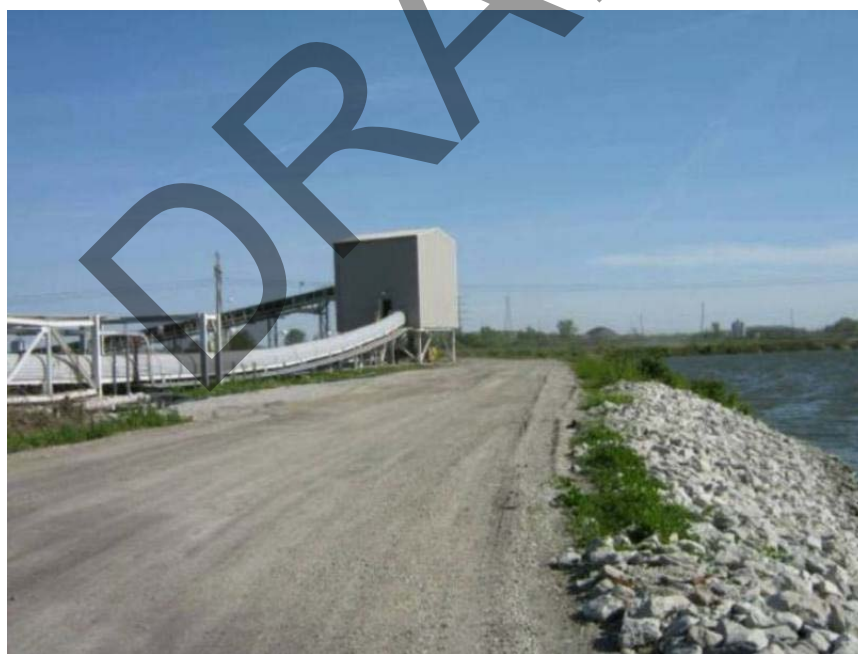
90. Ash Pond 3 - East Embankment Crest, Looking South

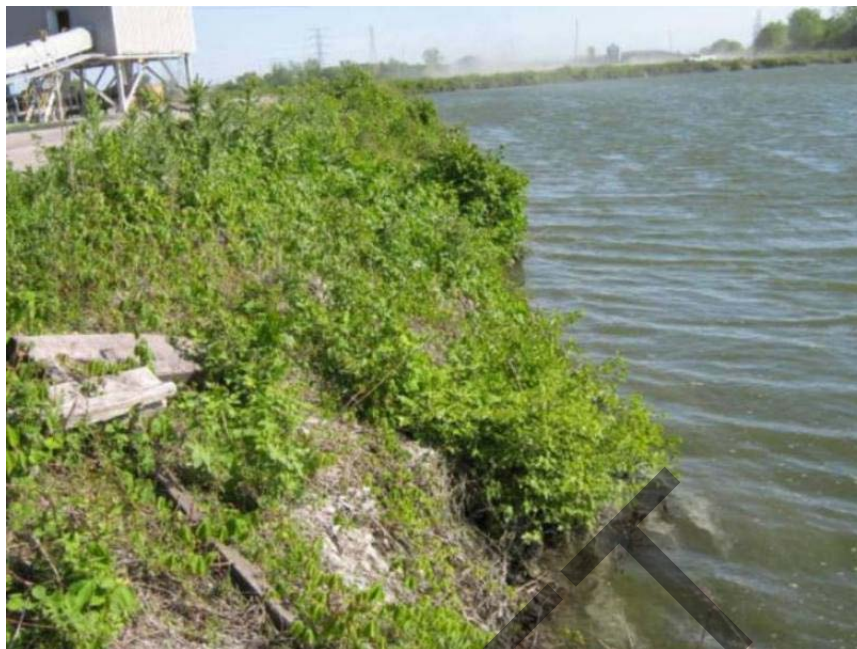
91. Ash Pond 3 - Beaching Along East Embankment Interior Slope, Looking South

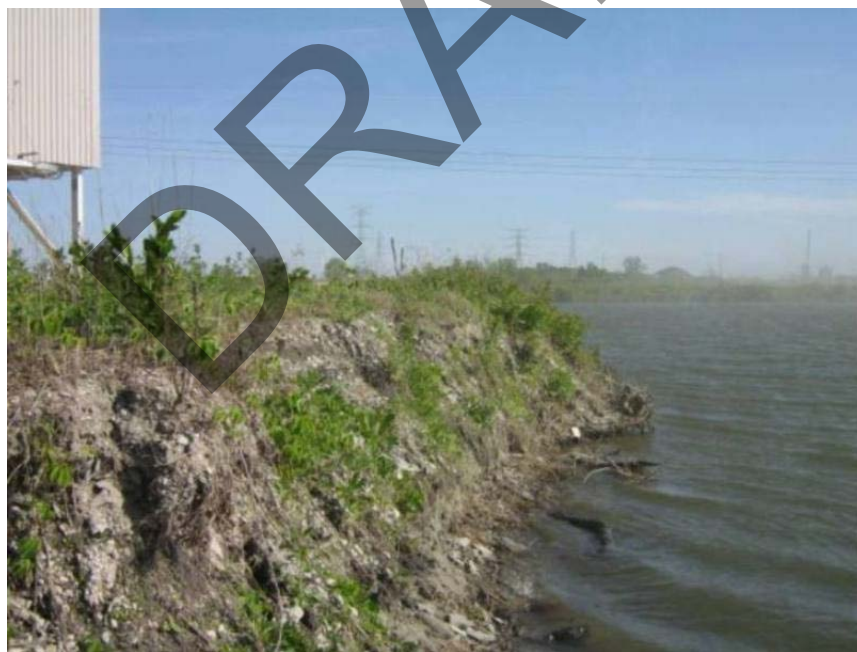
92. Ash Pond 3 - East Embankment Interior Slope, Looking South, Extensive Erosion and Steep Slopes

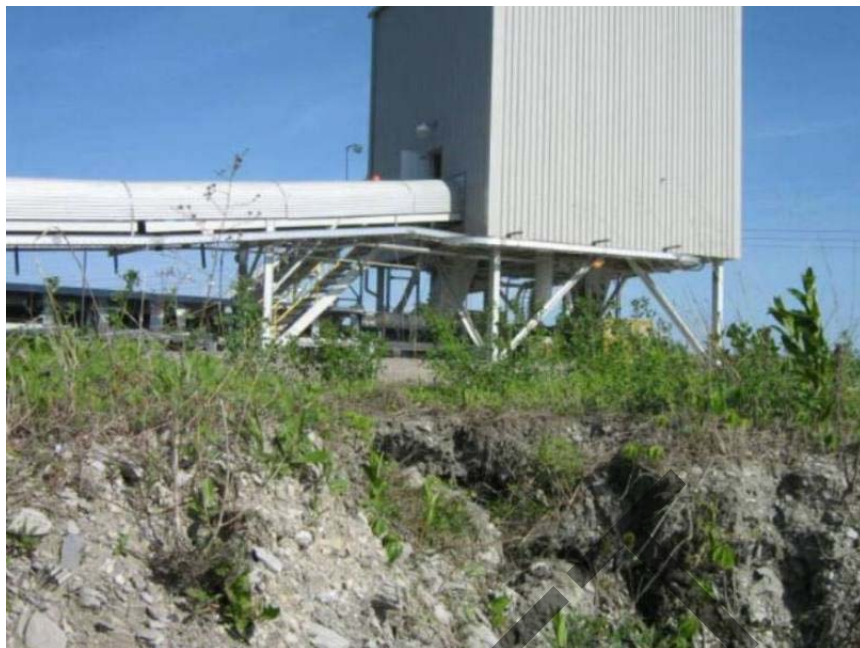
93. Ash Pond 3 - Erosion Rills on top of East Embankment Interior Slope

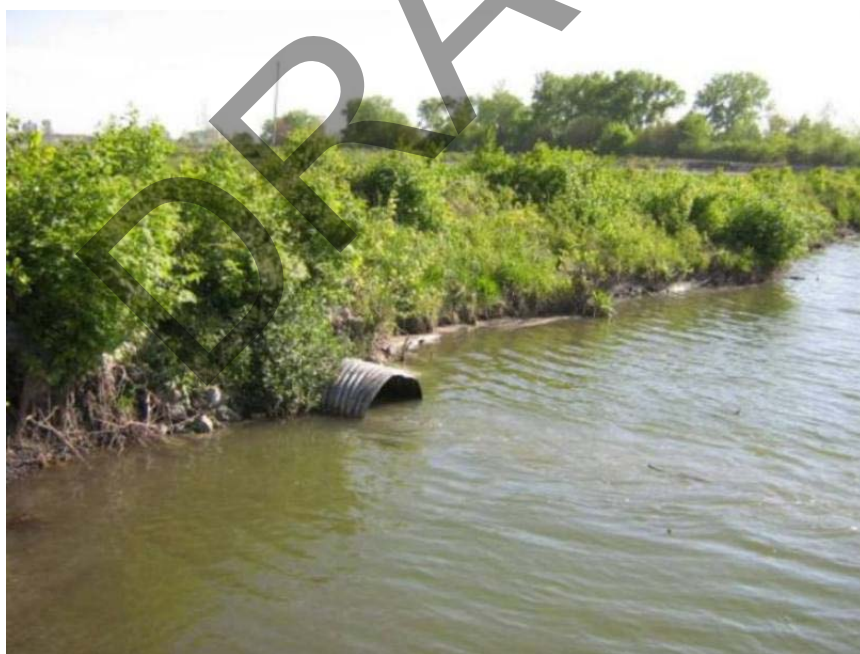
96. Ash Pond 3 - Inflow from Ash Pond 4A Located at Southeastern Corner of Pond

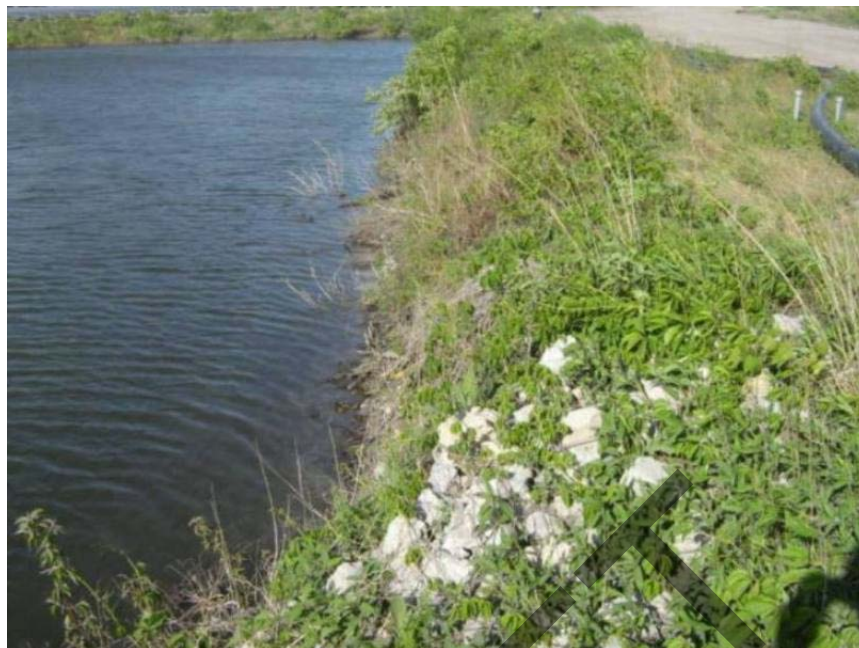
97. Ash Pond 3 - South Embankment Interior Slope, Looking East

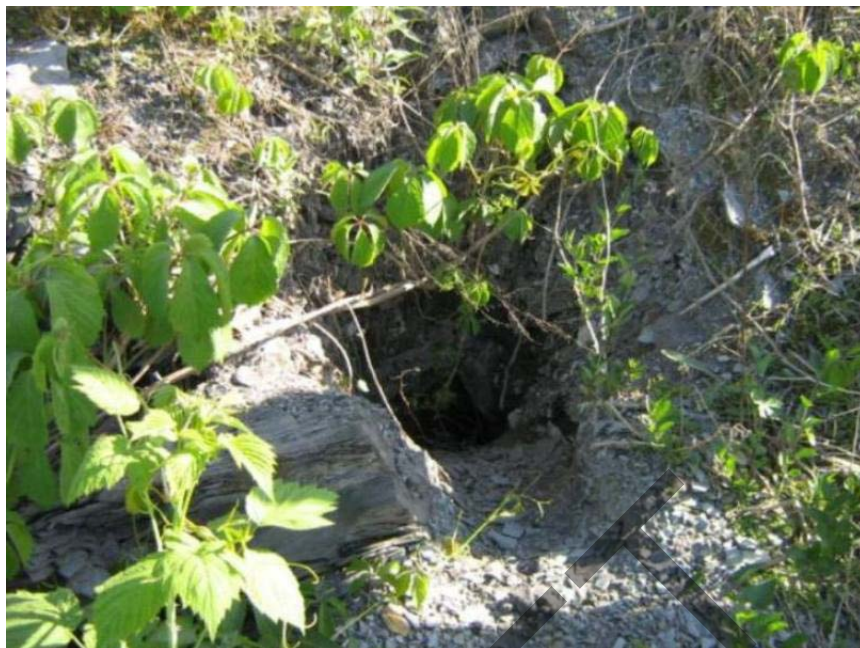
99. Ash Pond 3 - Rodent Burrow located in South Embankment Interior Slope

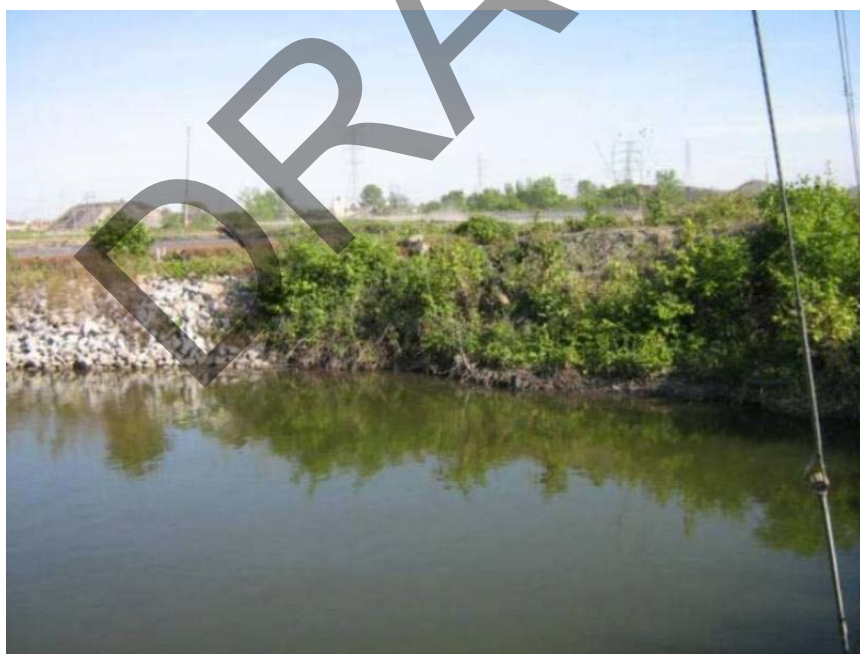
100. Ash Pond 3 - South Embankment Interior Slope, Looking South

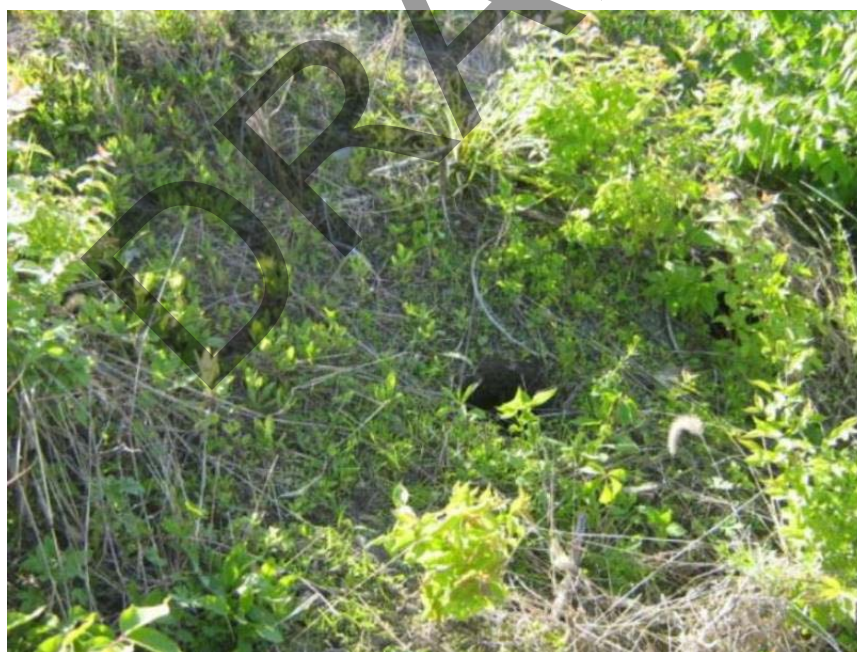
102. Ash Pond 3 - Rodent Burrows in West Embankment Interior  
Slope

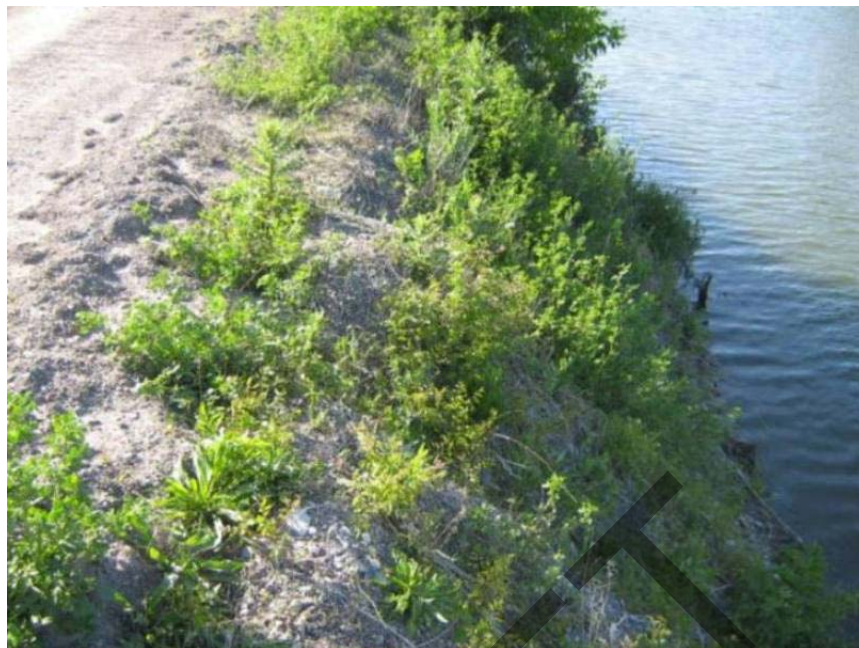
103. Ash Pond 3 - Erosion Rills and Beaching on West Embankment  
Interior Slope

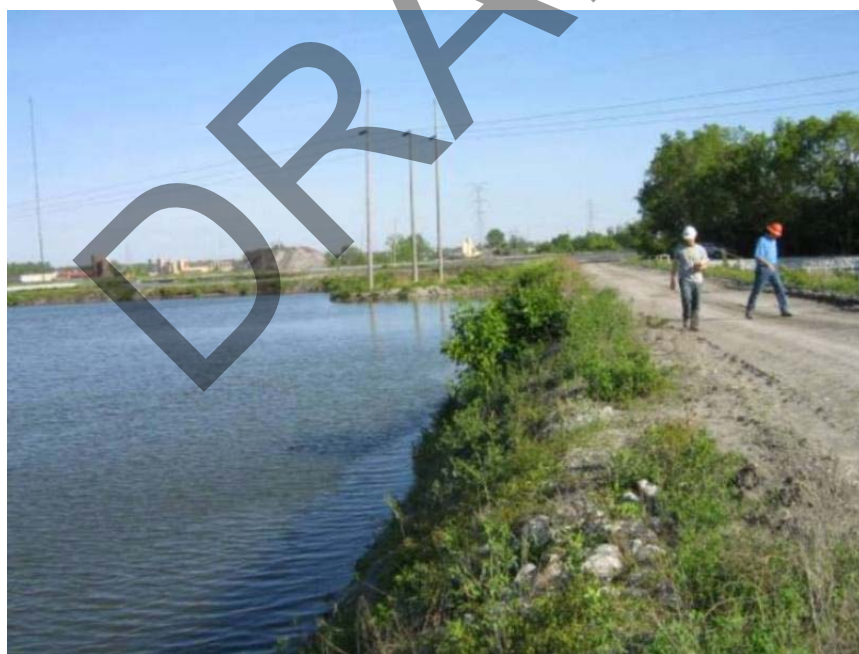
104. Ash Pond 3 - West Embankment Interior Slope, Looking South

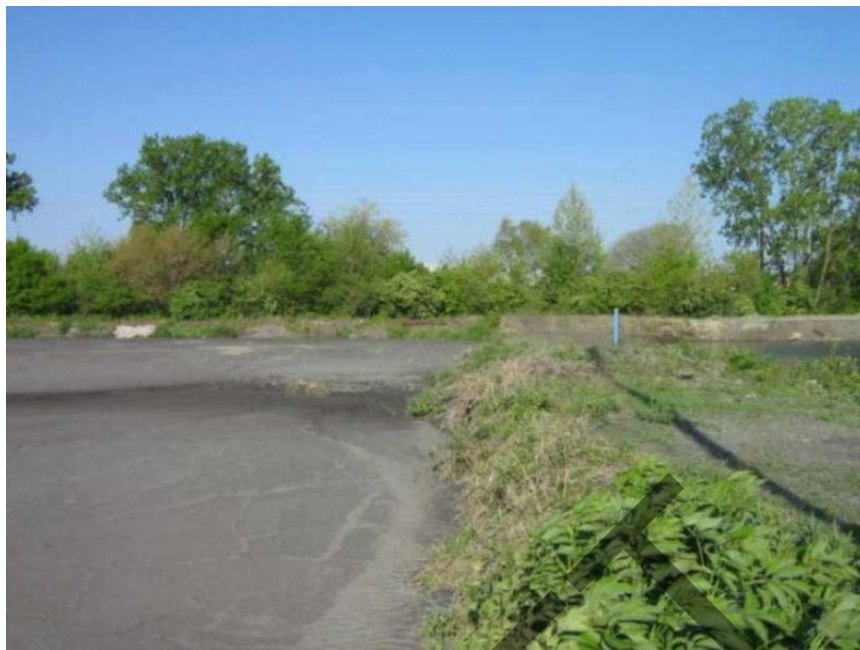
105. Ash Pond 4 - North Embankment Interior Slope, Looking West

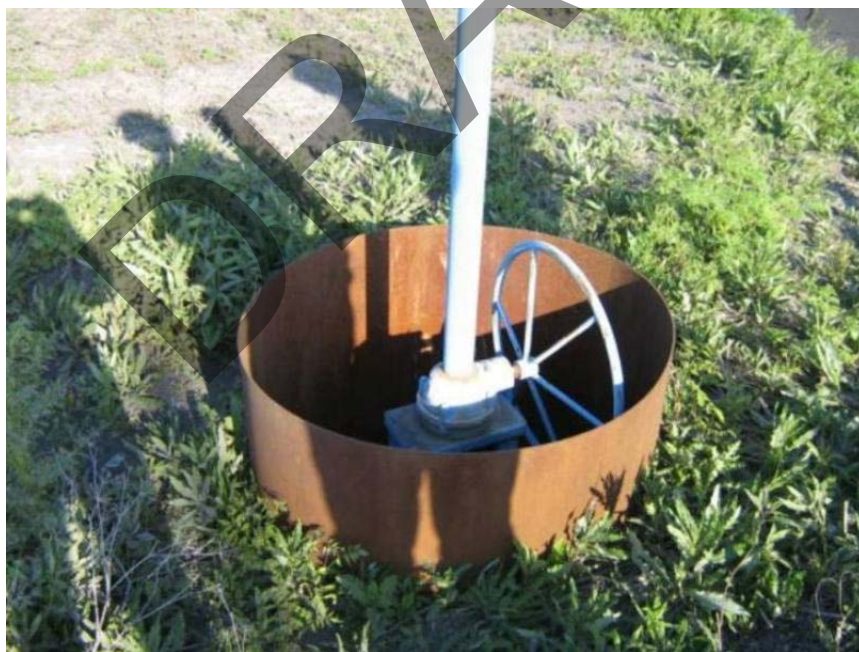
106. Ash Pond 4 - Gate Valve located on North Embankment Crest
